## D4.15 AUTONOMOUS LAST MILE PILOTS IN OPERATIONS

# Transition of EU cities towards a new concept of Smart Life and Economy

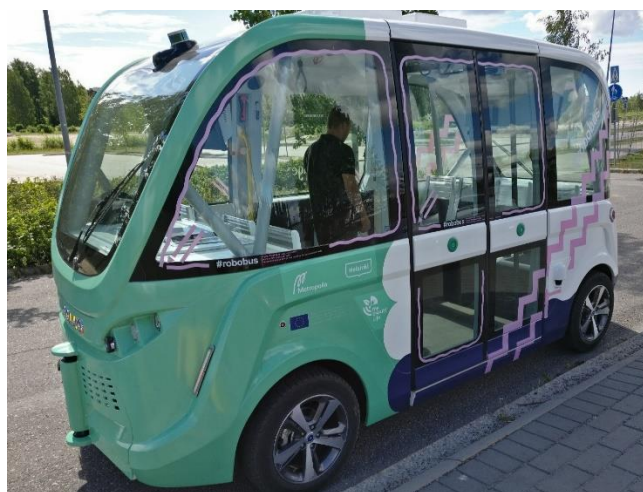
Figure 1: Navya Autonom Shuttle robot bus [Rutanen 2018]

Currently, there are not many commercialized robot bus products on the market but new businesses and companies are emerging at a great pace. The most commonly featured robot bus suppliers whose products are trialled all around the world are now French companies Navya and Easymile. Their buses, Autonom Shuttle (former ARMA) (Figure 1) and EZ10 (Figure 2) use similar technologies for the vehicle to position itself and detect obstacles on the route. Similar properties can also be generalized to be in other robot buses on the market or in buses that are in the process of development. The details described in this Deliverable are based on practical experience gained in various smart mobility related projects that Metropolia has been involved in and which have been dealing with robot buses. One of the above-mentioned robot buses, Autonom Shuttle, was piloted as part of mySMARTLife which is discussed also in more detail from chapter six forward in this Deliverable.

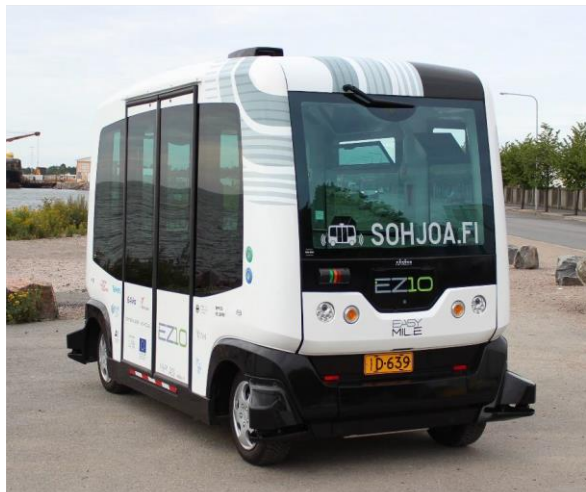
Figure 2: Easymile EZ10 robot bus [Lehmusjärvi 2016].

Robot buses use LiDAR radars also to detect obstacles on the path, which rationally placed and combined can see 360 degrees around the vehicle. In first models of the EZ10 shuttle used in project SOHJOA [Sohjoa Robot Bus Experiment 2016-2018] obstacle detection LiDAR radars were located in each corner of the vehicle around 30 cm above the ground. These radars detected obstacles in one layer and obstacles higher or lower from 30 cm was not detected. This resulted in the ADS failing to react for example to an open tailgate of a truck or a tail swing of a large bus on the path where the shuttle would most likely have hit without human intervention. In order to the vehicle to be able to safely operate in automated mode, it is vital that obstacles can be detected in several layers all around the vehicle. Newer EZ10 models (Figure 4) were later fitted with multi-layer LiDAR radars located in the front mask at both ends of the shuttle.

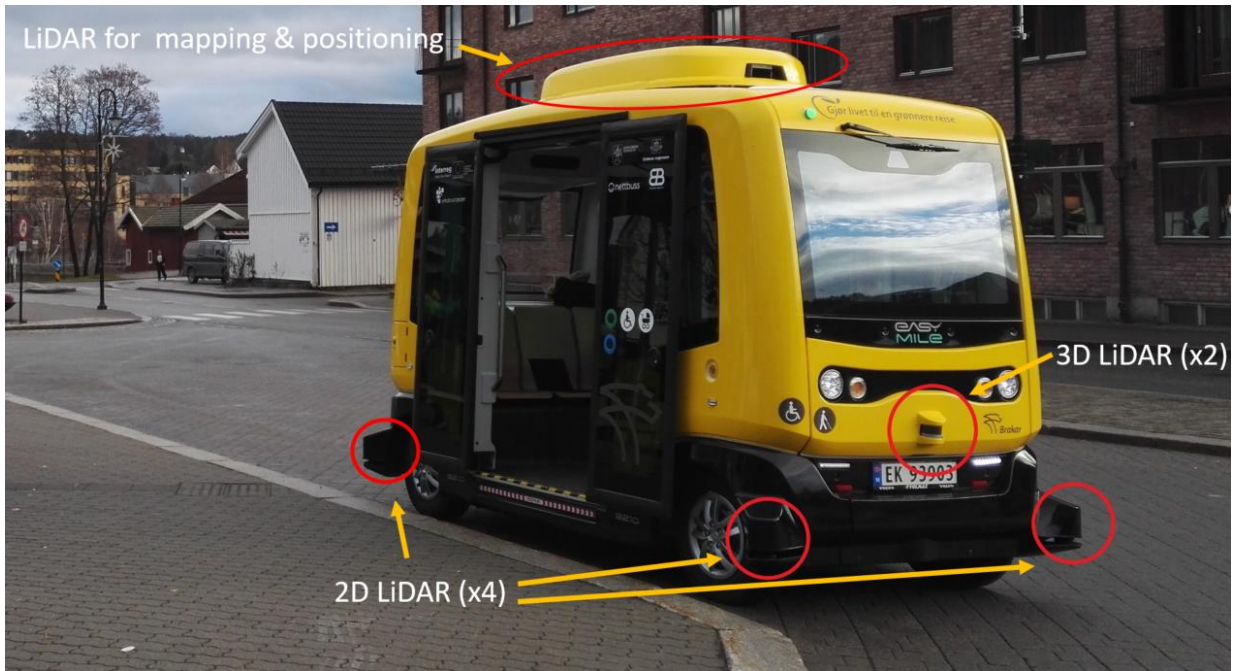
Figure 4: Easymile EZ10 Gen2 automated shuttle LiDAR radars [Ismailogullari 2018].

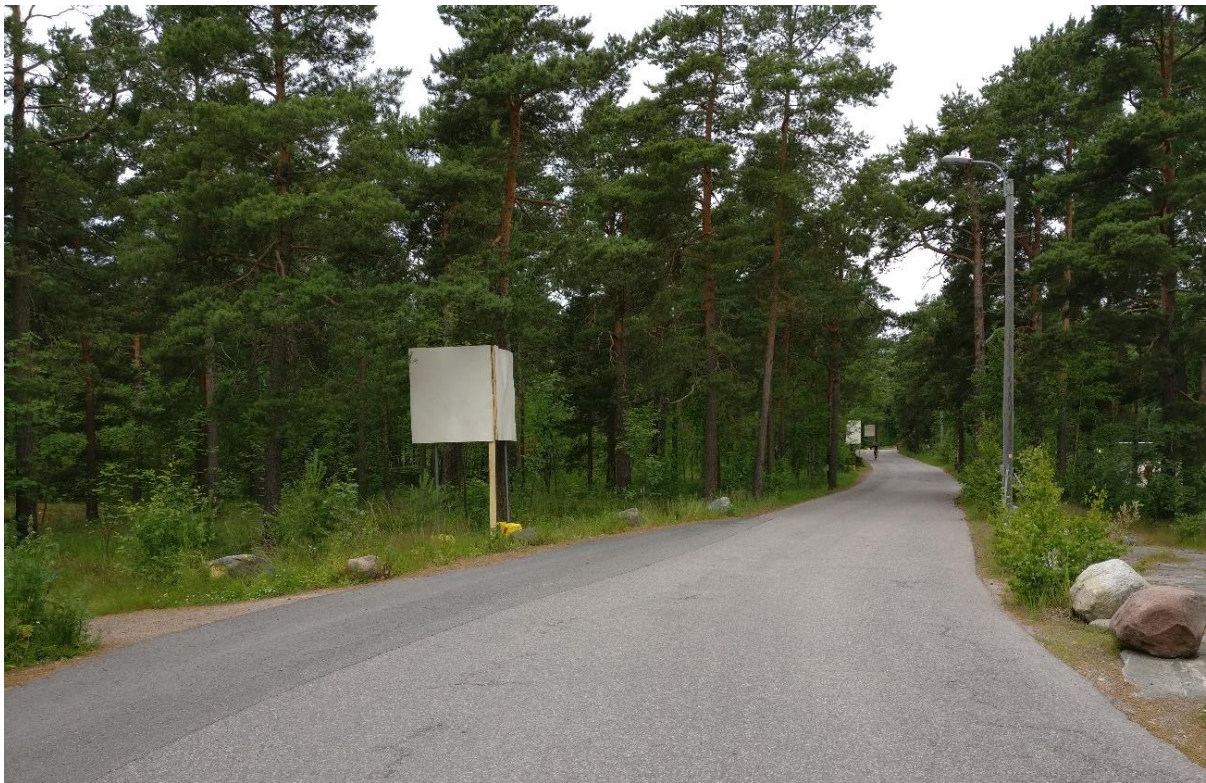
At the moment, robot buses are sensitive to changes in the environment and driving for example on a construction site where new buildings are built and where surroundings are often changing can be tricky. If the exact path where the robot bus is operating has to be changed for example due to construction site, it has to be programmed again or drive manually this part of the route. In addition, it can be impossible to operate in an environment where trees are in the immediate proximity of the route. In SOHJOA project, an attempt was made to program an Easymile EZ10 to operate in an environment as shown in Figure 6. There was even an attempt to build structures in several spots along the route to help LiDAR positioning but this did not work out. Trees and leaves are constantly moving which prevents LiDAR positioning to work properly while they can also block connection to satellites. Other vegetation such as grass and bushes next to the path can cause problems while the bus can see them as obstacles and brake unnecessarily.

Figure 6: Unsuitable operating environment for a robot bus [Rutanen 2017].

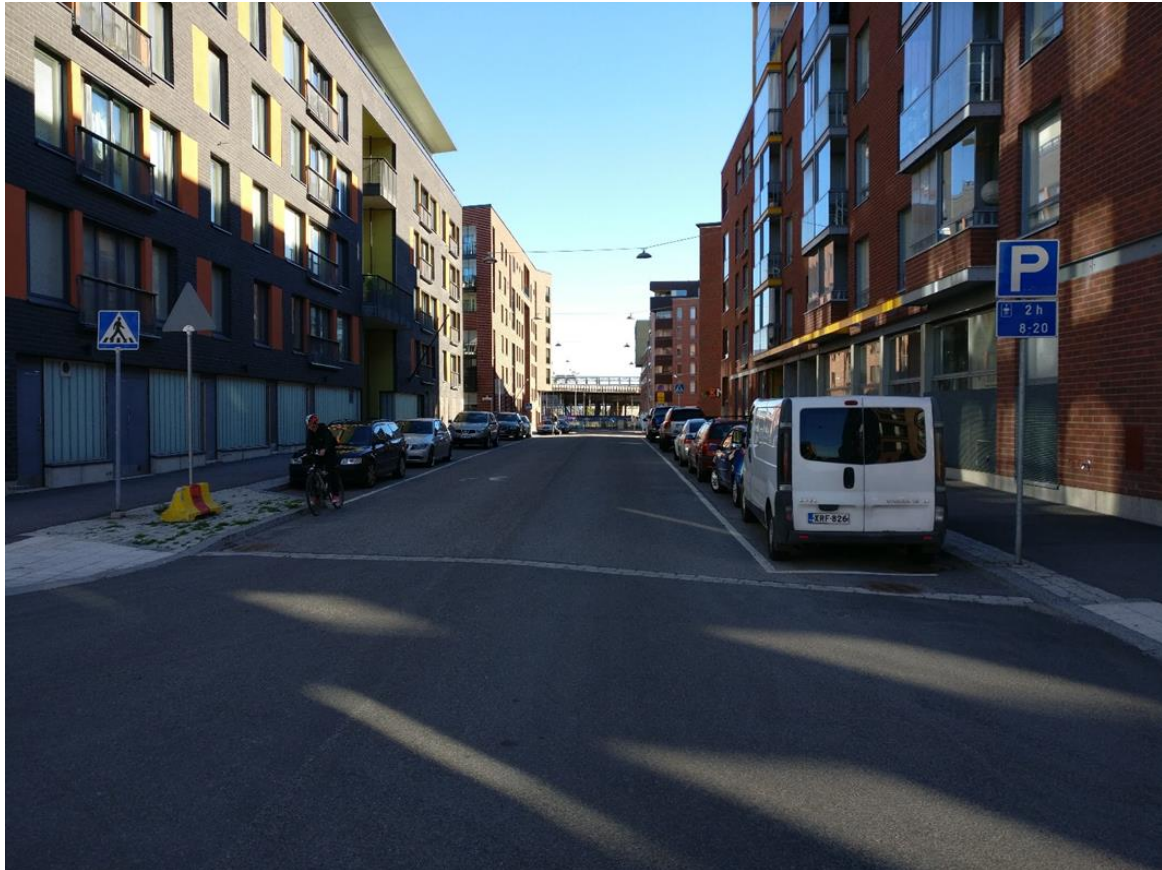
Figure 7: A well-suited urban environment and infrastructure for a robot bus in Helsinki Kalasatama [Rutanen 2017].

Because robot buses cannot currently overtake obstacles automatically, roadside parking spots should be clearly marked or roadside parking should be completely prohibited in intended operating areas. The lane where the bus operates should not be too narrow so that it can operate smoothly and will not pointlessly slow down for example because of parked vehicles or vegetation next to the street. Figure 7 from Kalasatama and Figure 8 from the Aurinkolahti area in Helsinki represent relatively well-suited urban environments and infrastructures for a robot bus. In both areas the speed limit is 30 km/h and vehicles should park in dedicated areas on the driveway or outside of it.

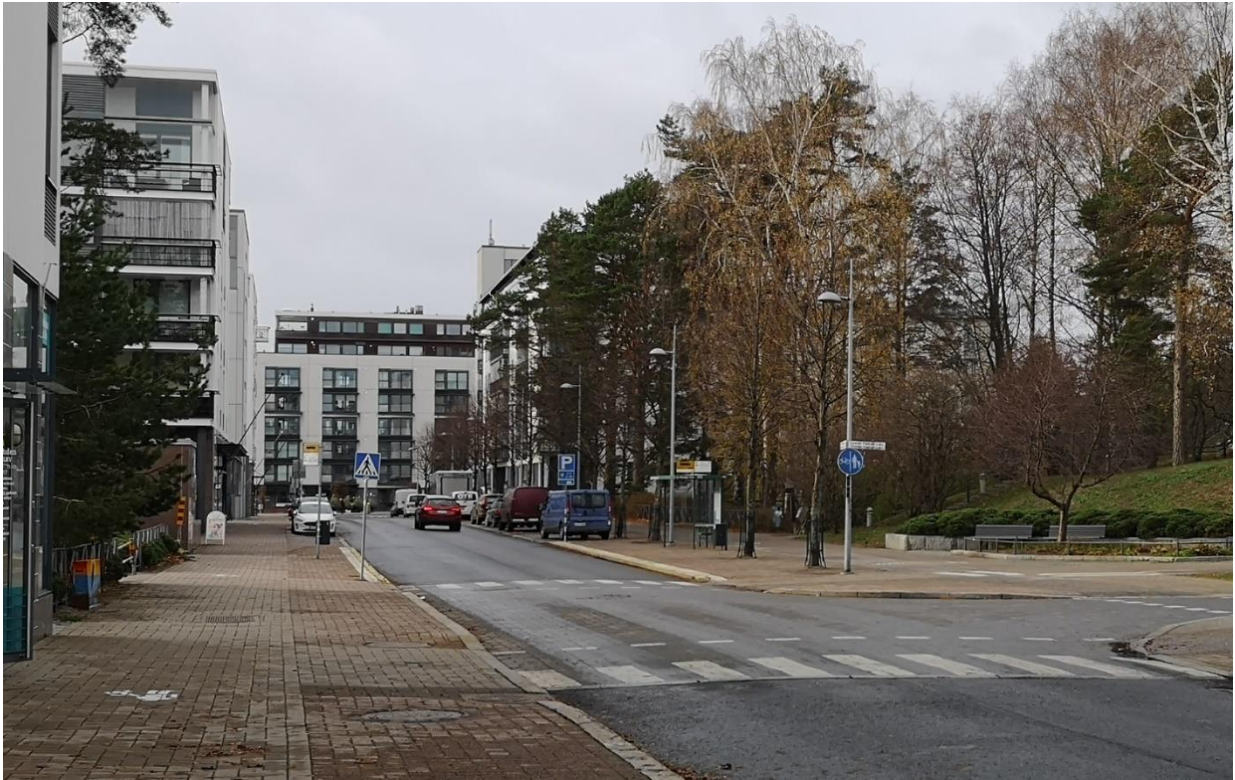
Figure 8: A well-suited urban environment and infrastructure for a robot bus in Helsinki Aurinkolahti [Arffman V. 2018].

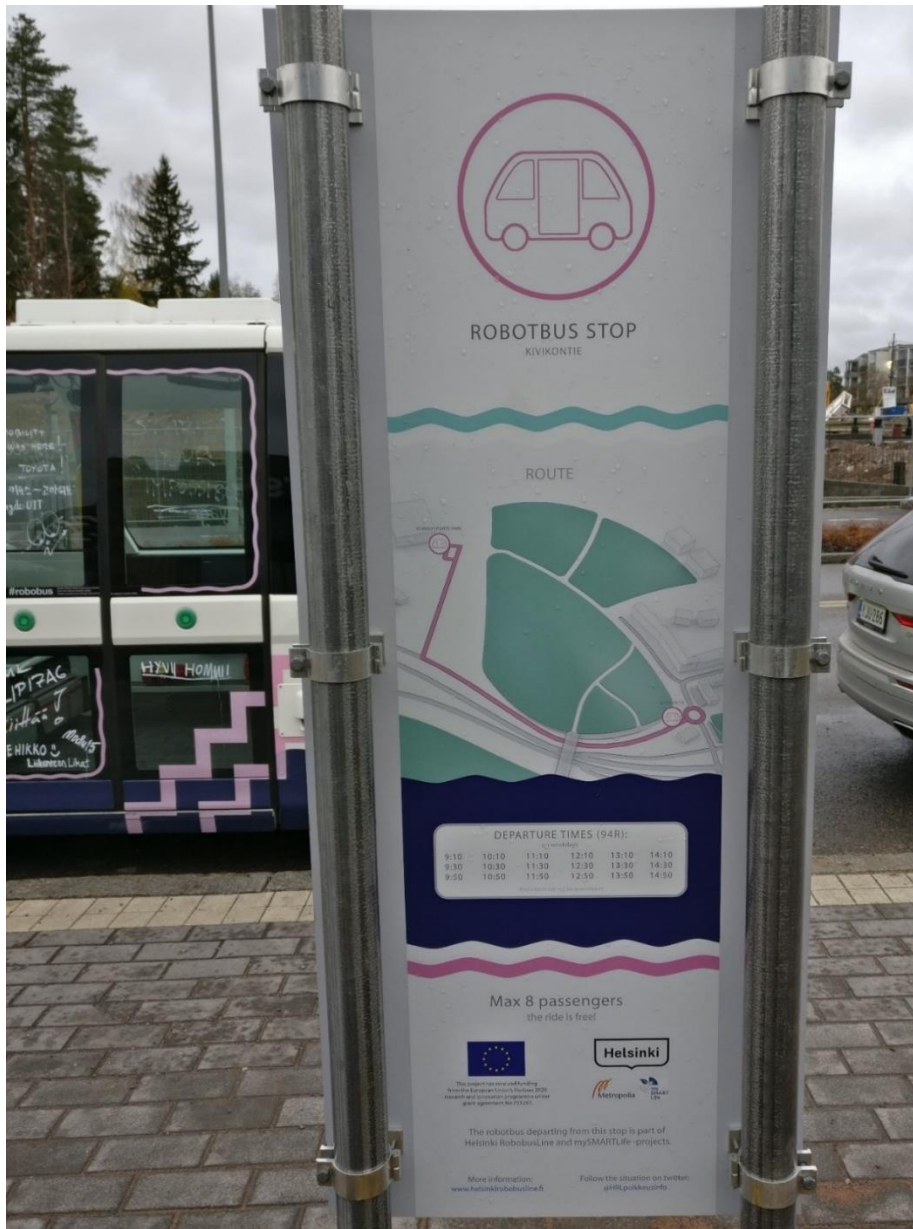
Figure 13: Robot bus stop sign at Kivikonlaita road [Rutanen 2018].

Even though the other end of the shuttle’s route was on a stop that were used by HSL buses, separate bus stop signs to describe the pilot was used on the stops as shown in Figure 13. The signs described among other things the station name, route and departure times. One side of the sign was written in English and the other in Finnish.

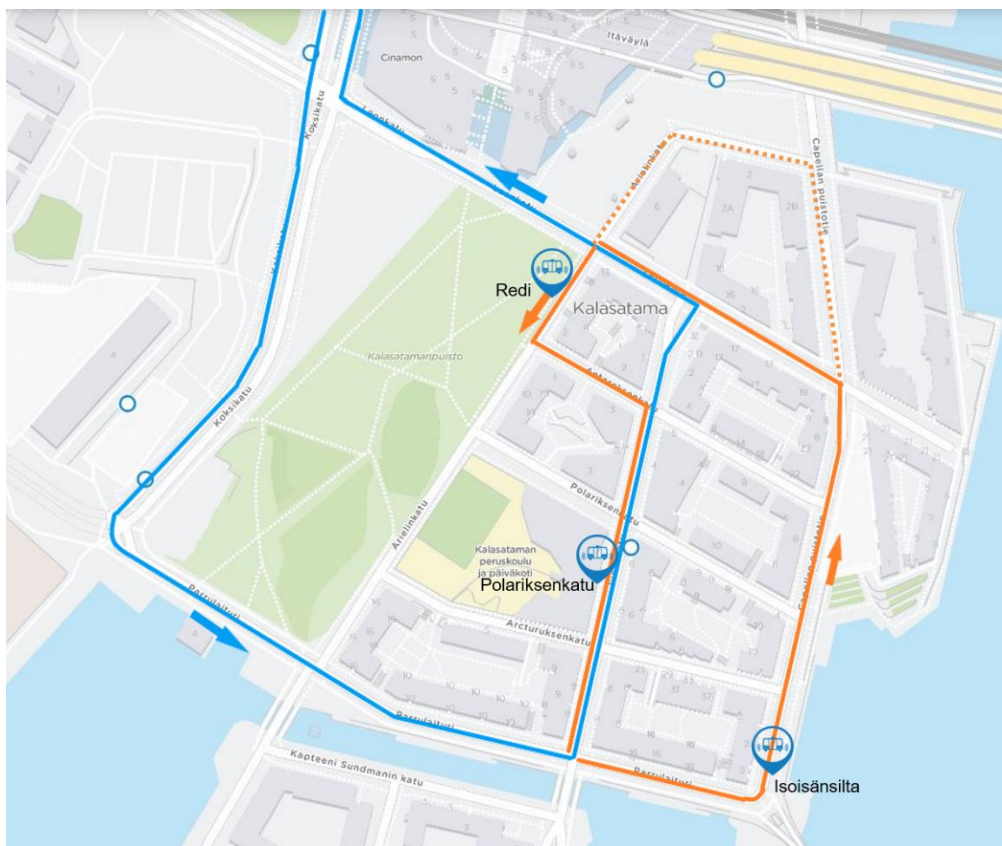
First, it was planned to have four bus stops and a bit longer route described with the orange dashed line in Figure 16. This extension would have passed a settlement apartment as well as enabled having a bus stop closer to the Redi shopping mall and the Kalasatama metro station. After discussing with the city, it turned out that there was going to be built a kindergarten next to Arielinkatu street during the summer and some temporary traffic arrangements would be implemented on the streets due to this project. This would have most likely required programming of the changes in the path of the shuttle or increased the amount of manual driving. Therefore, the route was shortened, and, finally, it was covered by three bus stops, all of which were specifically arranged for the robot bus to be used during the pilot. The names of these bus stops were Redi, Polariksenkatu and Isoisänsilta; Redi being the closest stop to the Kalasatama metro station and Isoisänsilta the stop at the other end closest to the bridge leading to the zoo. The route was operated in counterclockwise. HSL bus lines 50 and 59, described in blue colour in Figure 16, were operating partly on the same route in the opposite direction and the robot bus sometimes confronted these buses on Junonkatu street where one of their official bus stops was (named as Polariksenkatu as well) and in the crossing of Junonkatu-Parrulaituri streets.

Figure 16: Kalasatama robot bus route map [Arffman V. 2020]. (Map data: Reittiopas 2020).

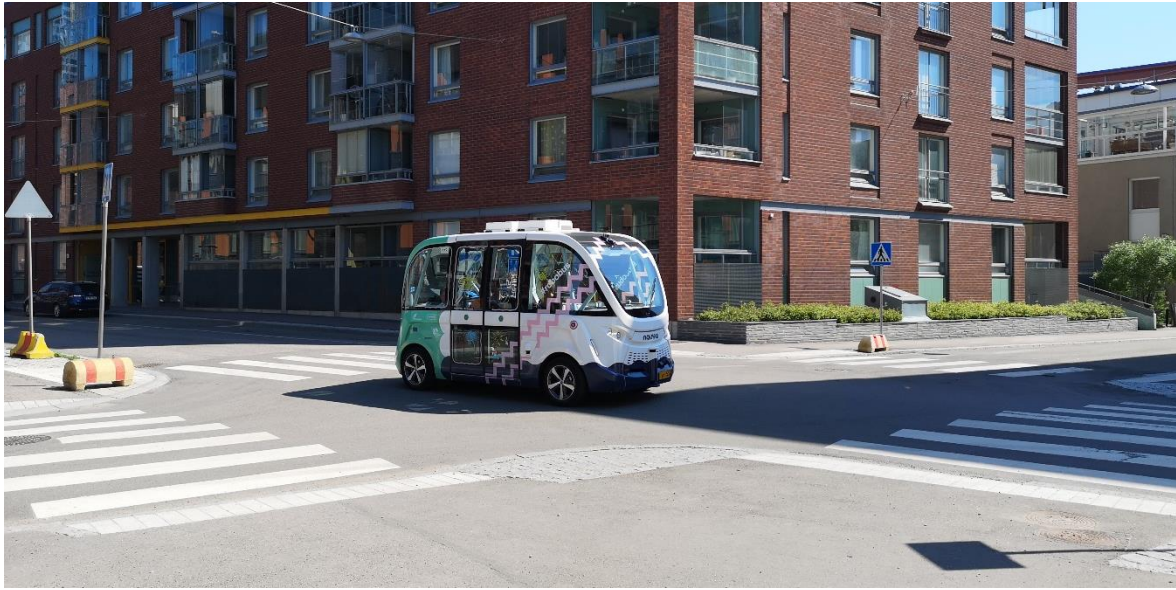
Figure 19: Typical intersection and environment by the route of the robot bus in Kalasatama [Rutanen 2019].

All of the 10 intersections by the route were uncontrolled T-junctions (or similar to these without any traffic lights nor signs indicating the right of way) but in total 6 of them were such where the robot bus did not have right of way. At these 6 intersections the bus had to give way for the vehicles coming from the right according to the rule of the road. Figure 19 depicts a typical intersection and the overall looks of the environment in the Kalasatama area as well as by the route of the robot bus. Speed limit in the area was 30 km/h and traffic density was quite low but the HSL bus lines operated within around 10 minutes intervals which was much tighter compared to Kivikko. Also, some construction trucks occasionally drove on the same streets where the robot bus operated even though instructed to use other ways when driving to the near built new neighbourhood at Sompasaari. Of course, other road users such as passenger cars, bicycles and pedestrians were also present.

Overall, the environment by the Kalasatama route was completely different than in Kivikko, as it represented an urban district with buildings near on both sides of the streets. The positioning of the shuttle could be thus done mainly by using the LiDAR radars. There was no vegetation next to the roadside either. On one hand, the area was still somewhat under construction and there was roadside parking nearly by the whole route, though only in clearly marked places as seen also previously in Figure 7. The streets in Kalasatama were between 6-7 m wide (3-3,5 m per lane to one direction), much narrower than in Kivikko, and around 2 m wide area was reserved in addition for parking next to the driving lanes and the roadside.

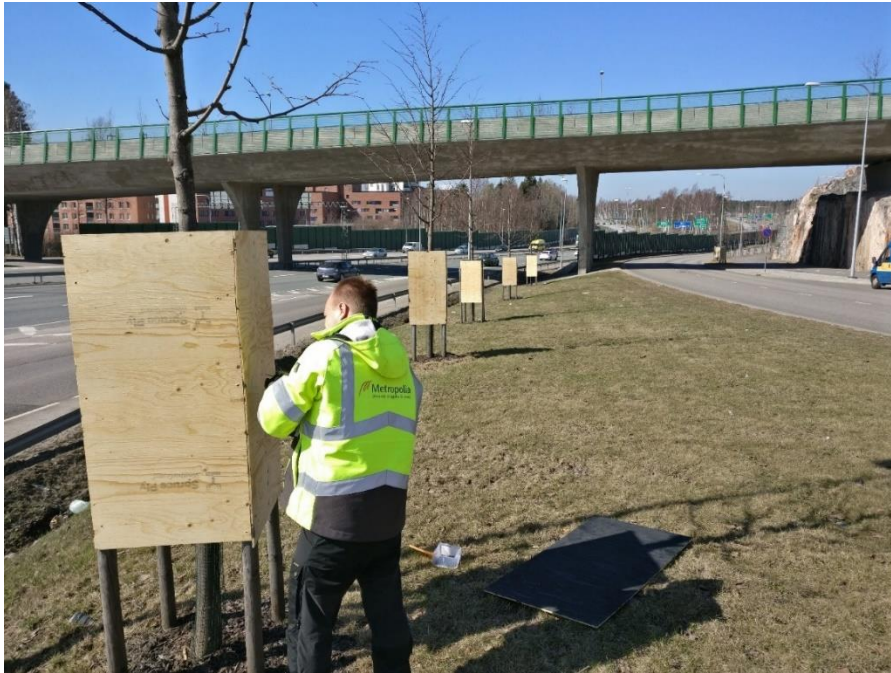
constructs were installed near the bridge. In total ten sets of wooden panels were installed, nine of them around the frames of growing trees (Figure 20) and one around a lamppost (Figure 21). After the bridge was passed, it took around 20 seconds for the bus to gain connection again to the satellites. Because of this, the constructs had to be installed on a longer distance, not only under the bridge or its immediate vicinity.

Figure 20: Installation of wooden constructs to frames of growing trees near the bridge at the Kivikonlaita road [Rutanen 2018].

The most laborious arrangements on the site were related to the bridge on the Kivikonlaita road. When the robot bus drove under the bridge it lost connection to satellites. Solid objects such as the pylon of the bridge and rock around the bridge was found to be inadequate for the bus to locate itself using only LiDAR radars. Additional stationary reference points for localization were deemed necessary, which is why wooden

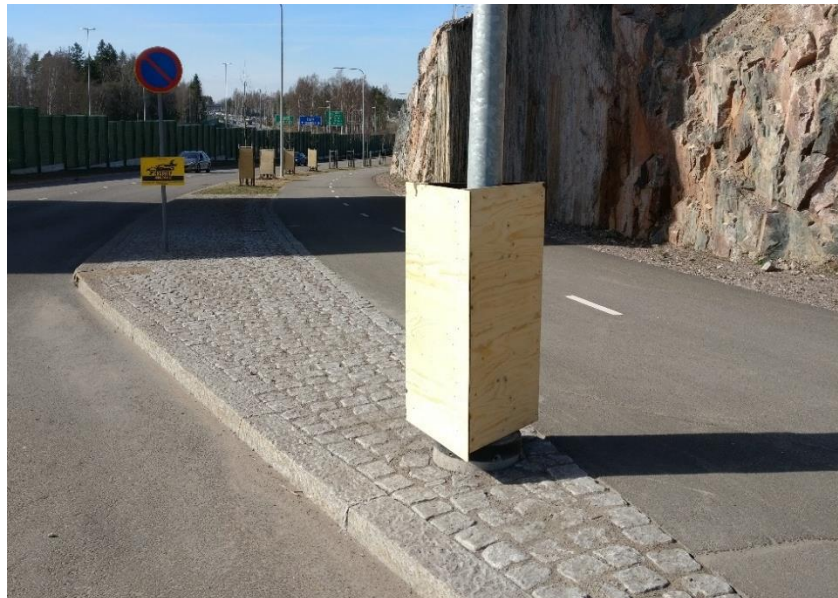
Figure 21: Wooden construct around a lamppost near the bridge at Kivikonlaita road [Rutanen 2018].

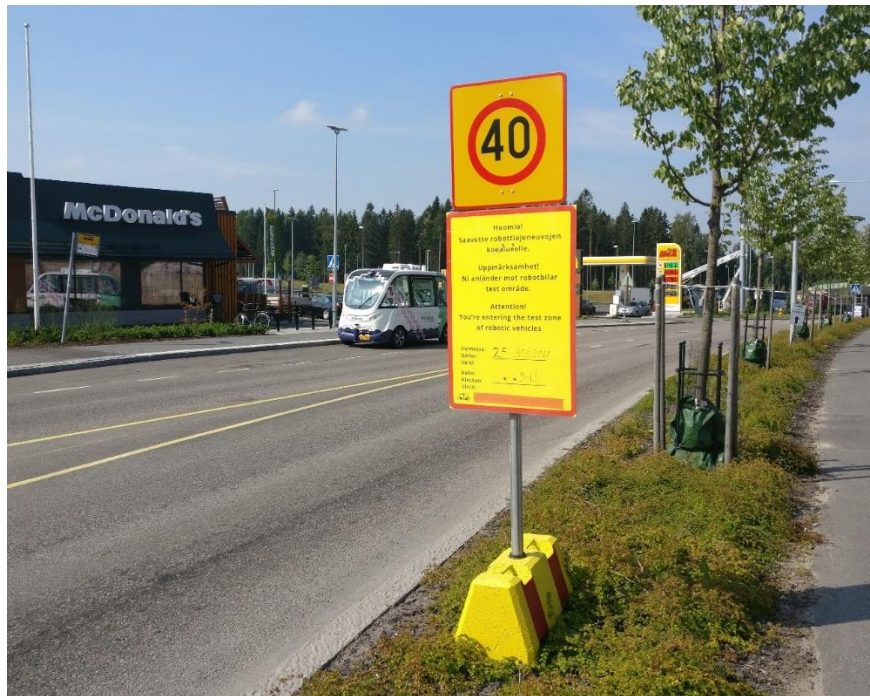
Figure 23: Robot bus test zone sign and 40 km/h area speed sign at Kivikonlaita road [Rutanen 2018].

In the robot bus experiments in Finland, traffic signs have been previously used to warn other road users of the ongoing trials in the area. Creating a safer test environment has also required lowering the speed limit,

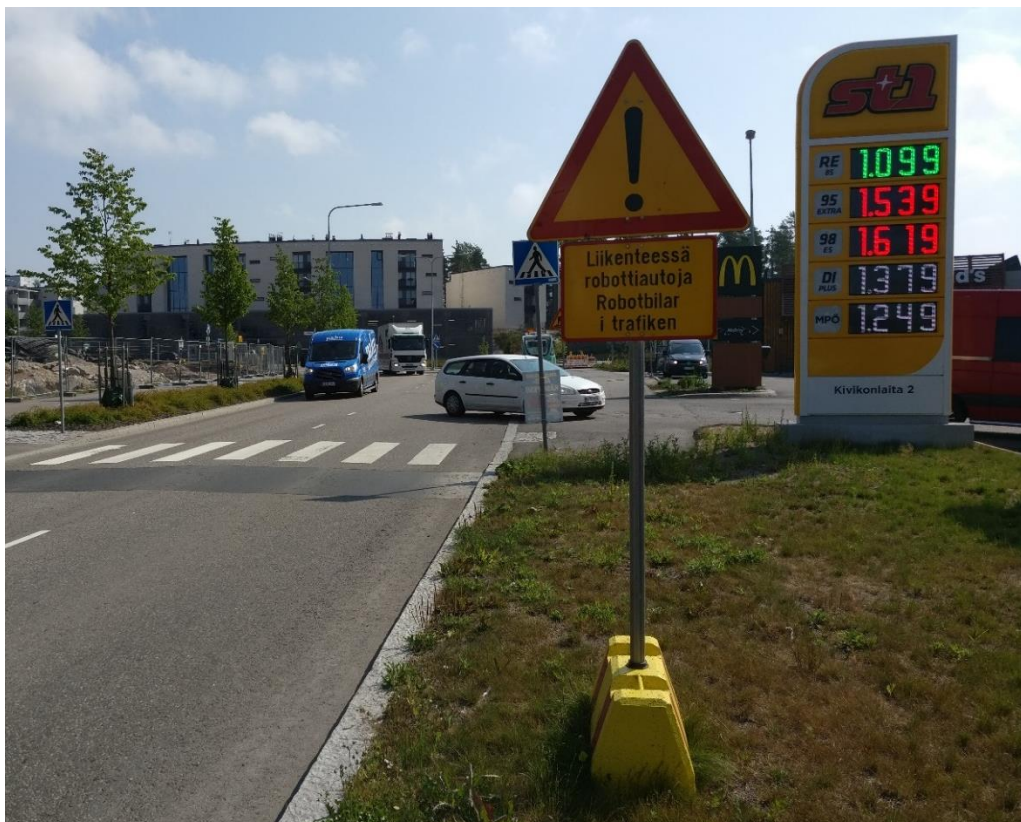
Figure 24: Robot bus warning sign and zebra crossing on the path at Kivikonlaita road [Rutanen 2018].

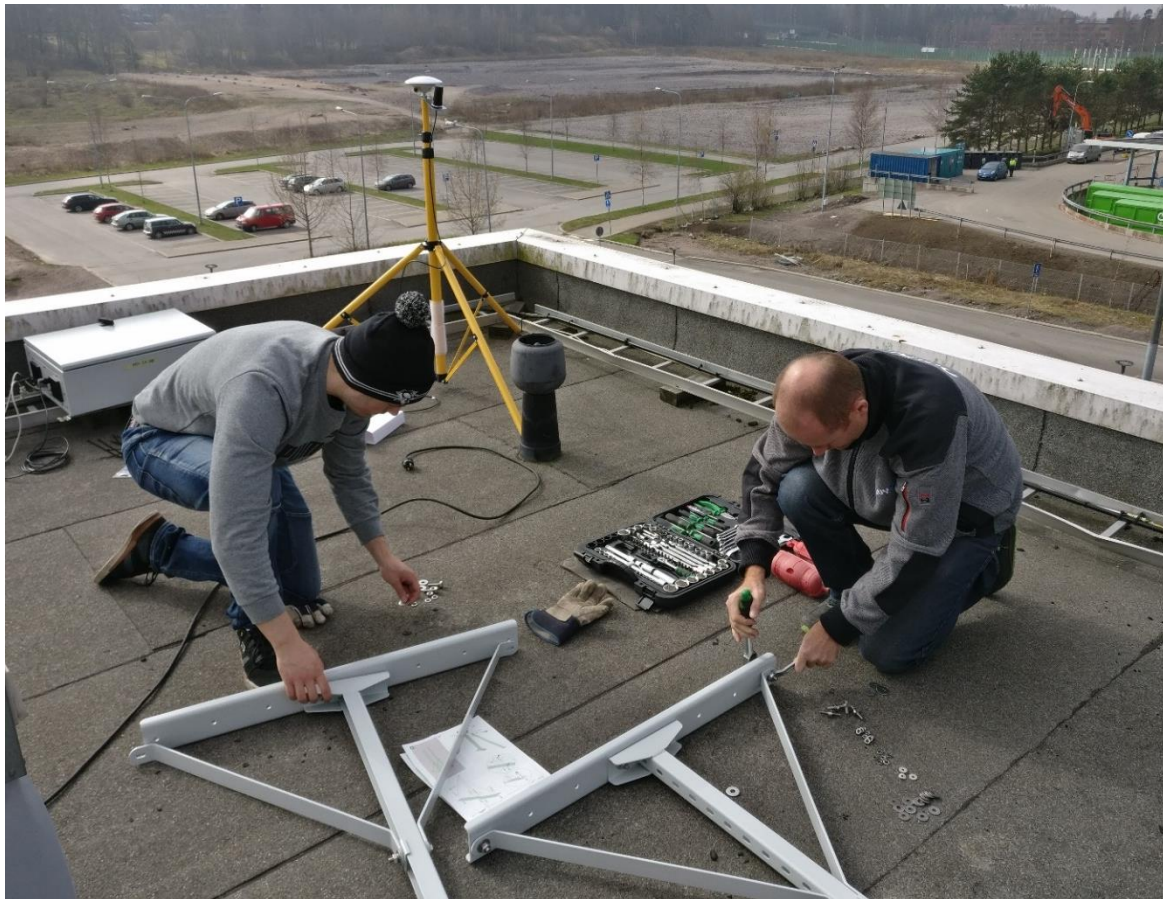
Deployment (including mapping and programming of the route) of the shuttle took 10 days starting on 2nd of May and ending on 14th of May which was the day when passengers could hop on in the shuttle. Just before the actual route programming a GNSS RTK reference station was installed on the roof of a skiing hall located at the other end of the route by the Kivikko sports park stop as shown in Figure 25. Installation was made together with Navya and Metropolia, and this was basically the first task of the deployment in which the bus supplier was involved in practice on site. For proper satellite connection and communication between the shuttle and the station, the station had to be installed in a high and open space near the route. It had to be also secured that the antenna, the yellow mast seen in Figure 25, did not move during the pilot. Because the reference station was placed at the other end of the route, connection with radio frequencies did not work on the whole route and connection was usually lost around the Kivikontie stop. However, the communication between the shuttle and the reference station could be also handled through 3G/4G which covered the connection loss at this point.

Figure 25: Fixed RTK GNSS reference station installation on the roof of the Kivikko Skiing hall [Rutanen 2018].

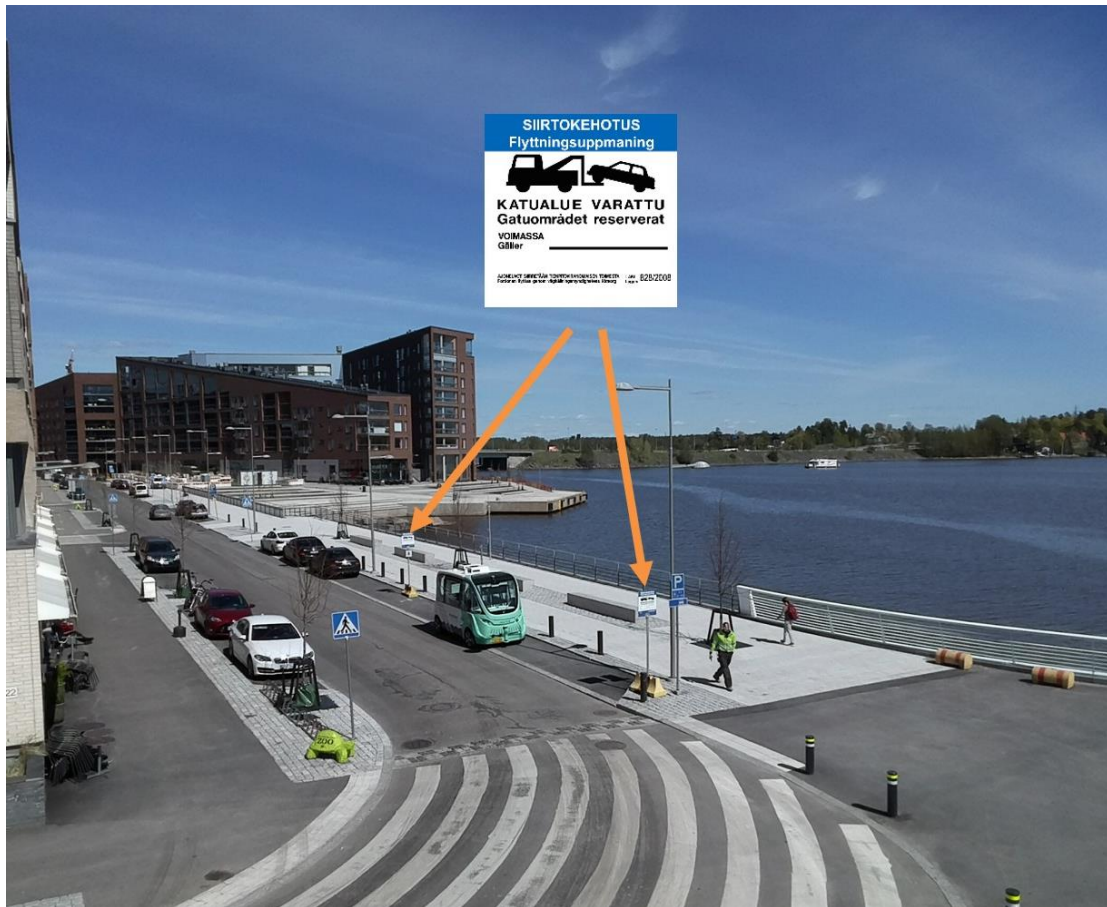
Figure 27: Isoisänsilta shuttle bus stop and specific signs to reserve the area [Arffman V. 2019].

Unlike in Kivikko, road side parking spaces were reserved to be used as the shuttle’s three bus stops. The reservation was made by using specific signs that are used to reserve a street area in the city as seen also seen in Figure 27 in case of the Isoisänsilta robot bus stop. If other road users would have parked on the reserved spots, the parked vehicle could have been towed away. Though this arrangement did not seem to be clear enough as vehicles were parking on these reserved spots, nevertheless, complicating the deployment process and operation of the shuttle. As vehicles were parked at the shuttle’s bus stops they were hindering the complete route programming and adjusting of the shuttle’s trajectory when driving to the stop. Additional work had to be done to get the vehicles off the spot, and sometimes that work took a longer time.

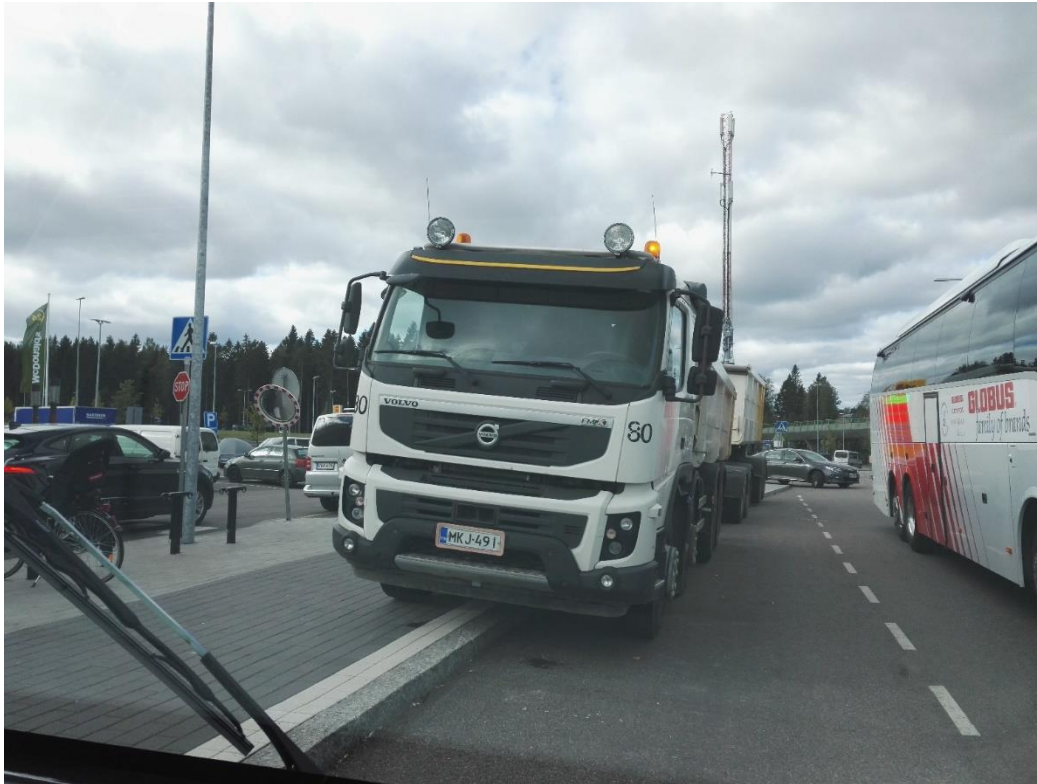
In Kivikko, both the environmental and technical incidents appeared in the same proportion causing around 50% each of the listed 91 incidents. Incorrectly parked vehicles on the route were the most common issue during the pilot causing approximately 70% of the listed environmental issues. Usually vehicles were parked at the Kivikontie stop which prevented the shuttle from being able to stop at the bus stop and continuing back to the Kivikko sports park (Figure 29). Vehicles could also be parked at the regular bus stop near the Savikiekontie road or on the Kivikonlaita road on the allowed street parking area slightly too much outside of the dedicated area in which the case operator had to manually overtake them or position manually the shuttle at the bus stop. Environmental issues could be related to vegetation next to the roadside as well to prevailing weather conditions, for example to heavy rain. In case of rain the shuttle could start to brake vaguely after which the operator usually made decision whether it was safe to continue the operation.

Figure 29: Incorrectly parked vehicle at Kivikontie bus stop [Ismailogullari 2018].

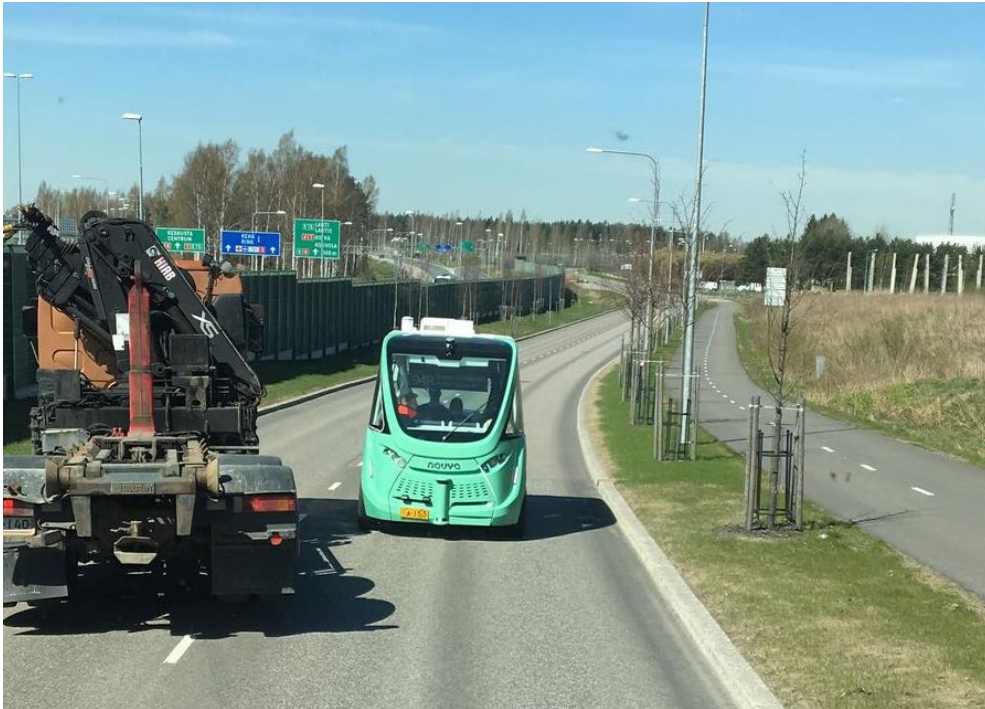
on a curve, which increased the risk for them to collide with incoming vehicles. Overtaking was not made easier by the fact that the shuttle was programmed to drive more on the left side of the lane to watch out for vegetation next to the roadside as seen in Figure 30. To avoid unnecessary and dangerous braking, the shuttle was driven manually on the fly when vehicles were overtaking it, which happened several times almost on every departure. Safety parameters related to the overtaking issue were attempted to change for less responsive but without success.

Figure 30: Overtaking truck on the Kivikonlaita road [Arffman J. 2018].

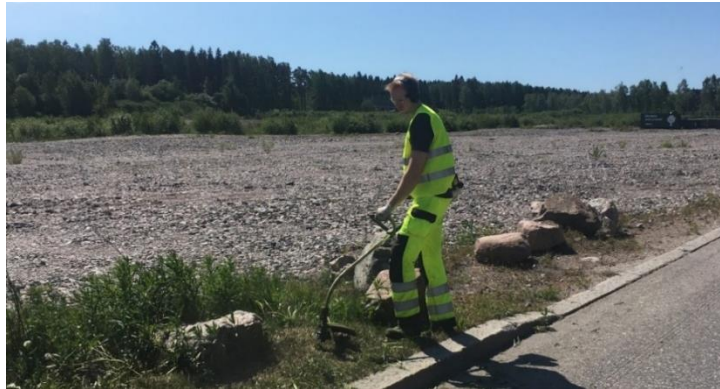
Figure 31: Project worker cutting grass from the roadside on Savikiekontie [Arffman V. 2018].

Vegetation by the shuttle's route was the reason for several false positive issues. The vegetation caused some unwanted braking or even caused the shuttle to stop completely which required the operator's intervention for the shuttle to continue operating. An effort was made to prevent this situation by cutting grass and bushes regularly (Figure 31). ADS of the shuttle seemed to be particularly sensitive for vegetation especially near the zebra crossings and intersections where the priority zones had been programmed.

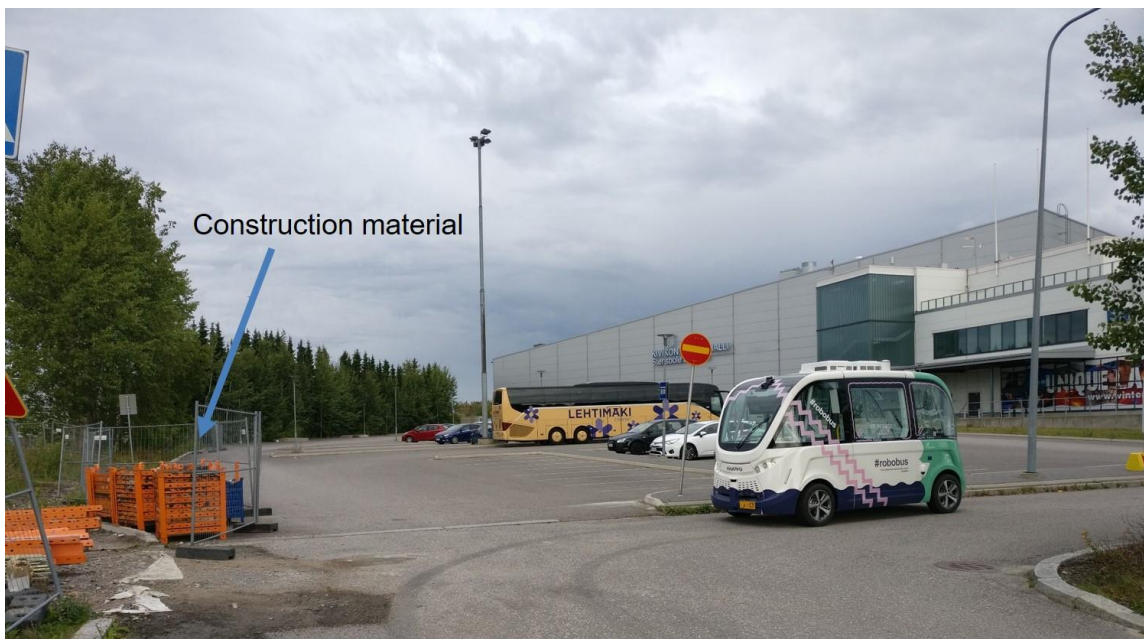
The shuttle could also be disturbed by any solid objective staying on its priority zones by the route. For example, as seen in Figure 32, some construction materials had been laid partly on the driveway where vehicles exit from a parking lot by the Kivikko sports park stop. A priority zone had been programmed in this exit area to give way for vehicles coming from the right. These materials were laying on the priority zone and the shuttle thought that there was a vehicle coming. The shuttle stopped and waited until the object had gone away, which, of course, in this case was not going to happen soon. The situation was solved and the priority zone bypassed by the operator inside the shuttle by pressing "GO" from the on-board control panel.

Figure 32: Construction material on the shuttle’s priority zone by the Kivikko sports park bus stop [Rutanen 2018].

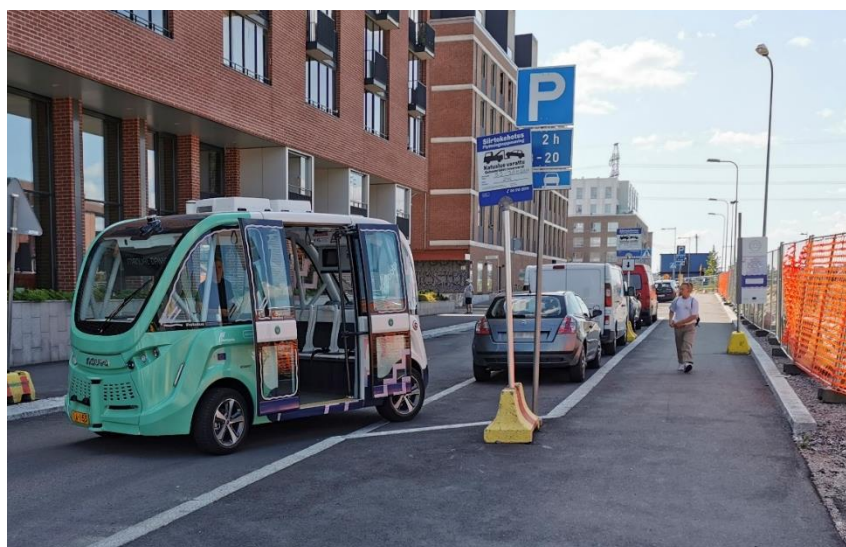
Figure 34: Vehicles parked at the Redi robot bus stop in Kalasatama [Rutanen 2019].

Compared with the Kivikko route, the route in Kalasatama was seemingly more suitable for the shuttle in use. The speed limit was only 30 km/h and the environment did not encourage driving fast due to the several zebra crossings and uncontrolled intersections. The number of vehicles in traffic in the area was also lower. However, in total 489 incidents were listed where the operator's intervention was needed. The difference between the number of incidents in Kivikko (n=91) is explained at least with the high number of roadside parking and narrow streets. Environmental incidents were classified to cause 82% of all the incidents 67% (n=402) of which were ensued because of parked vehicles. In this number it is not taken into account that, in several cases, the vehicle was parked on the same spot for a longer period of time, in whose case this obstacle had to be overtaken manually during each departure as long as the vehicle stayed on the spot. Typical situations where these vehicles were parked at some of the shuttle's bus stops as for example seen in Figure 34 in case of the Redi robot bus stop. These situations were listed to cause around 20 % of the incidents related to parked vehicles. For improving the information exchange of the ongoing pilot with a view to reducing incorrect parking, leaflets were distributed on the windshield of the parked vehicles such as depicted in Figure 35.

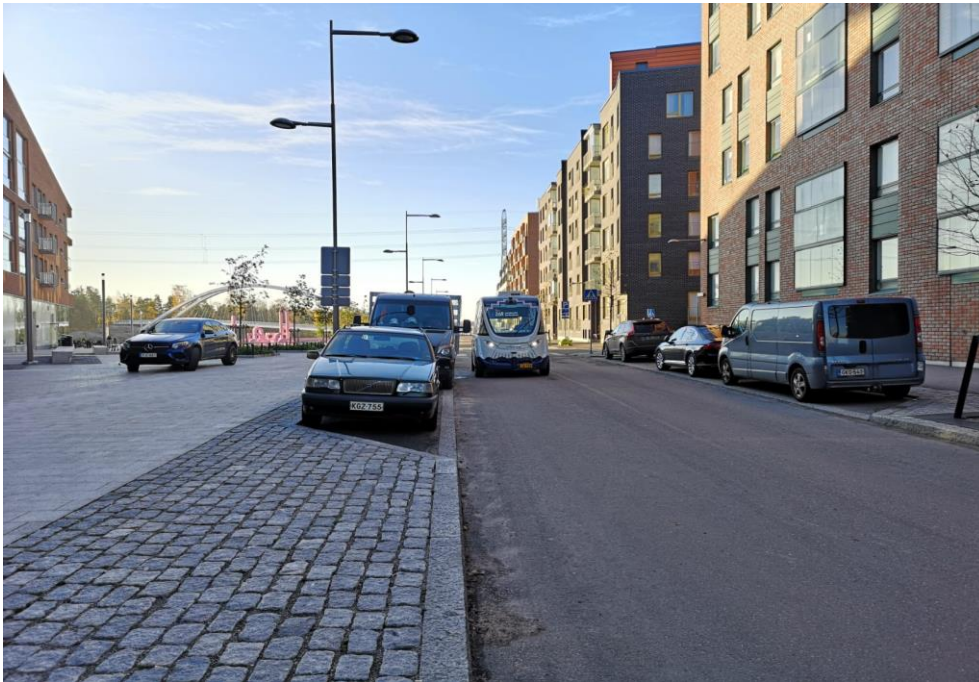
Figure 36: A parked van on the roadside on Capellan Puistotie street prevents the shuttle from moving [Rutanen 2019]. Encountering other vehicles on the route, especially the HSL bus lines 50 and 59 in the intersection of Junonkatu and Parrulaituri streets were causing around 17% (n= 402) of the listed environmental incidents. In these cases, the operator manually stopped the shuttle at a longer distance before the intersection to give space for the HSL bus to turn or made some manual manoeuvring if the shuttle had already reached the intersection. Sometimes the HSL buses allowed the shuttle to go first in the intersection, even though the HSL was coming from the right and had the right of way. In these cases, the operator had to override the priority zone for allowing the shuttle to continue the ride. Around 9% (n=402) of the listed environmental incidents were caused due to some construction equipment and material or street work as seen in Figure 37 near the Redi robot bus stop. The equipment on the road had to be passed by driving the shuttle manually as they were located partly on the shuttle's trajectory.

Around 50 % of the incidents related to parked vehicles were merged to be caused of situations where a vehicle or some part of it came a bit too much outside of the allowed roadside parking area, as seen in Figure 35 for instance. In Figure 36 at least the van’s mirror is coming outside of the allowed parking area on Capellan Puistotie street. In some situations a vehicle did not even seem to come outside of the allowed parking area, but the shuttle still stopped even though it would have had space to continue the ride on the programmed trajectory. This happened because the conditions for the required safety distance was not met – the trajectory of the shuttle was programmed perhaps a bit too close for the allowed roadside parking area at some points of the route. On the other hand, the reserved area for parking in Kalasatama was around 2

meters wide which seemed not be enough on every occasion for the parked vehicles to completely fit inside the dedicated parking area and maintain a sufficient distance to the driving road, if thinking of the impact on the operation of the shuttle. The width of the road by the route was otherwise quite narrow, varying between 6-7 meters, which prevented programming of the trajectory more on the left side of the lane as there would not have been enough space left for oncoming vehicles driving in the opposite direction to the shuttle.

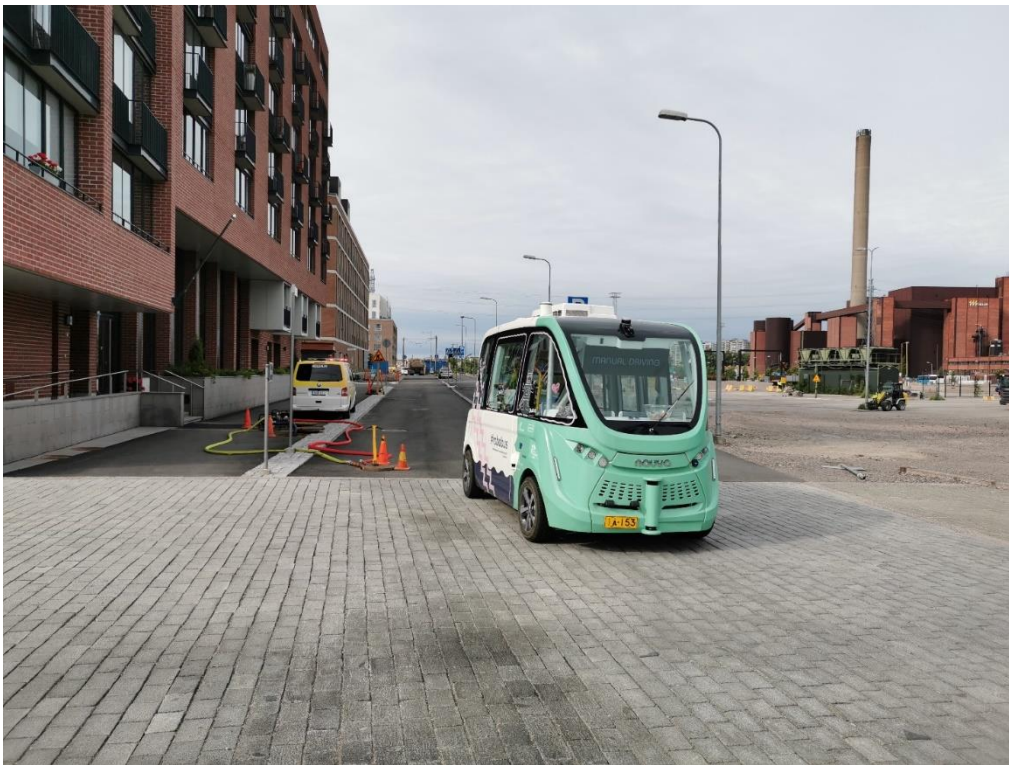
Figure 37: Street work on the shuttle's route near the Redi robot bus stop in Kalasatama required manual driving [Rutanen 2019].

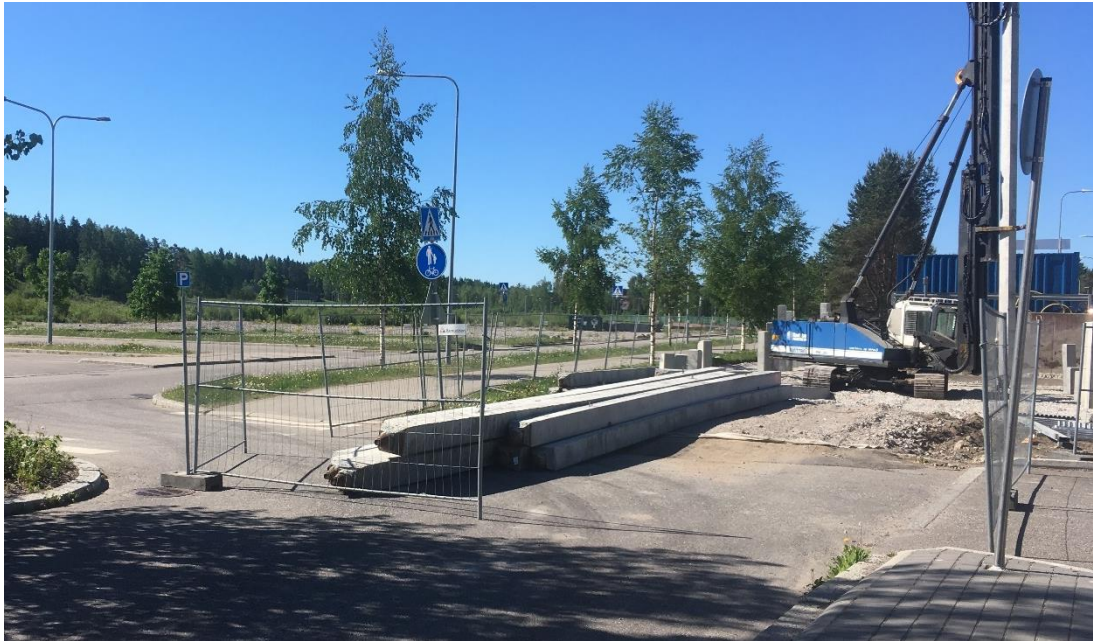
Figure 38: Construction supplies on the robot bus's path in Kivikko [Rutanen 2018].
