## D4.15 AUTONOMOUS LAST MILE PILOTS IN OPERATIONS

# Transition of EU cities towards a new concept of Smart Life and Economy

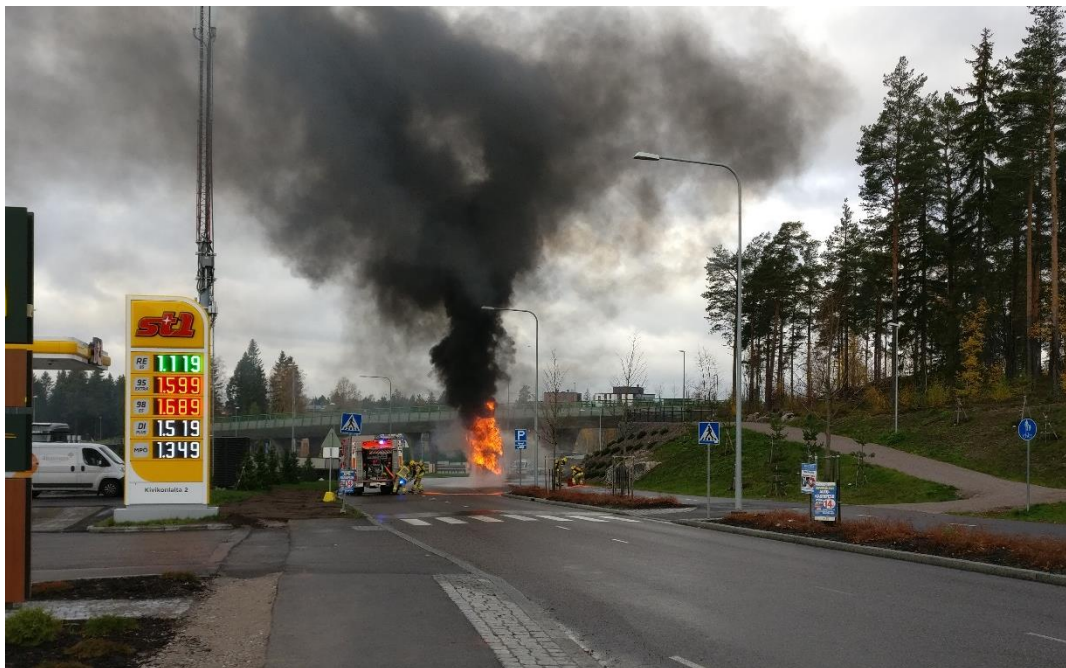
- **Abnormal traffic arrangements on the path.** In October a charter bus began to burn on Kivikonlaita road and was parked at the roadside (Figure 39). The traffic going pass the burning bus was stopped. Afterwards police guided the traffic on an alternative route passing a nearby gas station until the situation was settled. This alternative route had to be driven manually with the shuttle and a decision was made to stop the operation until the situation was cleared. Also training of a rescue department was arranged in Kivikonlaita during the pilot on one day. The traffic was guided through a detour but this did not affect the shuttle's operating schedule (was not counted as deviation) as the shuttle was driven manually through these arrangements.

Figure 39: Burning charter bus on Kivikonlaita road [Ismailogullari 2018].

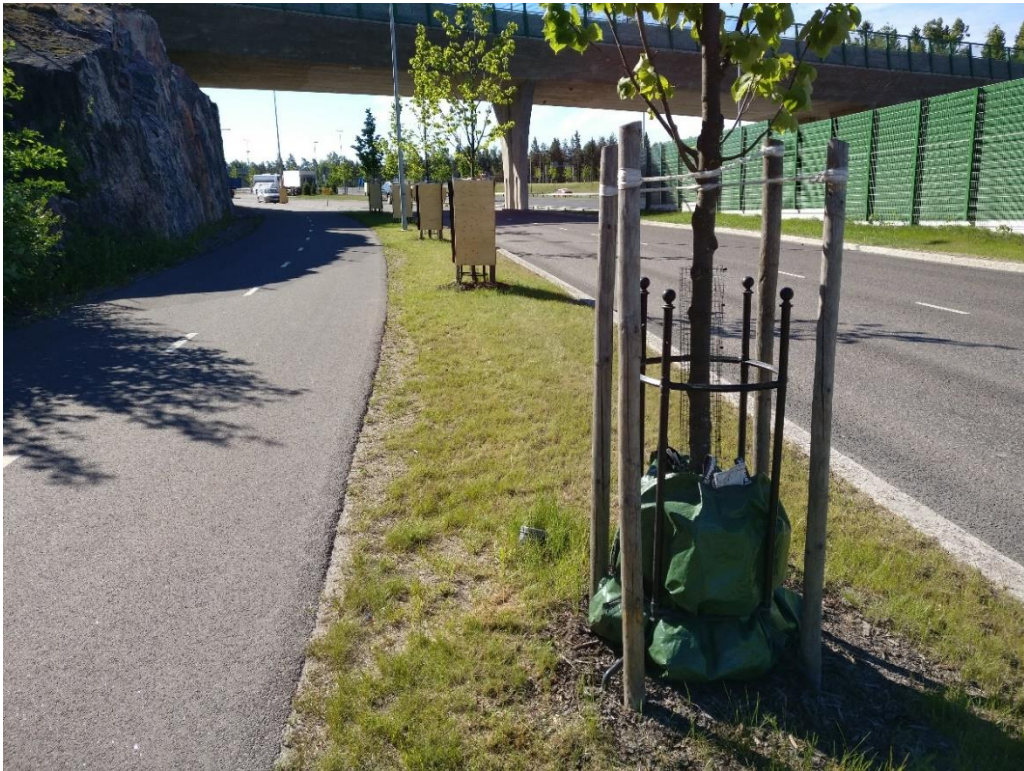
- **Installation of watering bags because of dry and hot weather.** The wooden constructs around the frames of growing trees used to improve the shuttle's localization under the bridge, needed to be cut at the bottom for fitting watering bags inside them (Figure 40). After cutting partly the constructs, the functionality needed to be tested but the action did not seem to affect the behaviour of the shuttle.

Figure 40: Watering bag between frames of growing trees (no wooden constructs on the nearest tree) [Rutanen 2018].  
Reasons for deviations during the autumn period (1.9-14.11.2018):

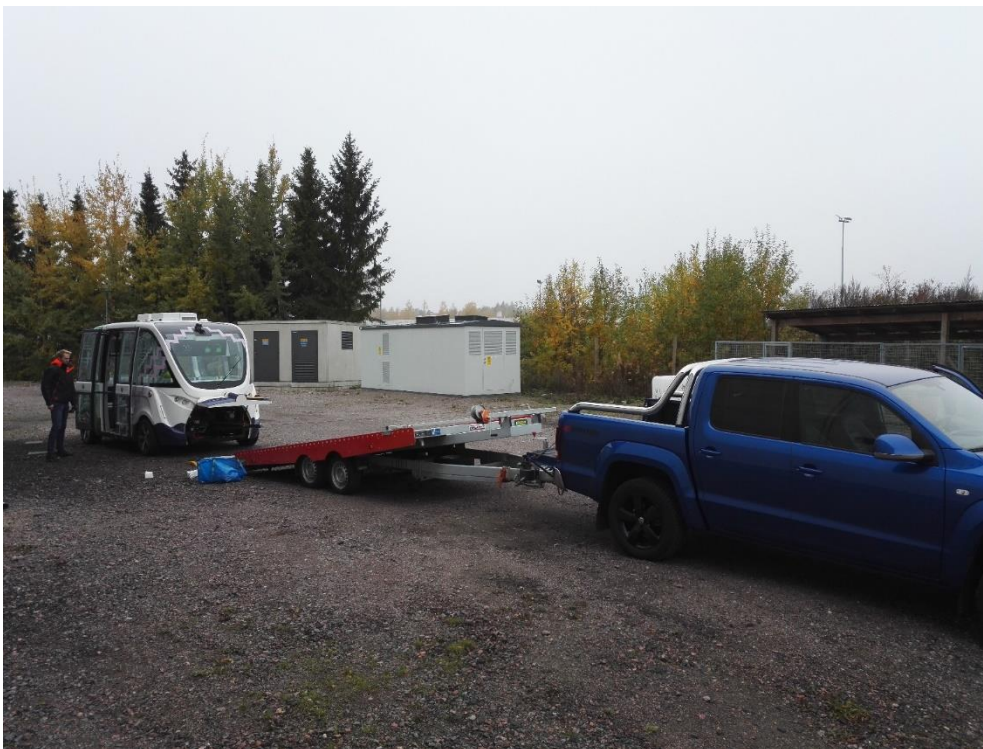
- **80V battery charging issue probably caused by cold weather.** The shuttle was stored outside throughout the whole pilot period. During the first weekend of October (6-7 October, 2018), the temperature was below 0C° which most likely caused an issue with the shuttle's 80 V battery after starting the operation on Monday. The shuttle was over-speeding (driving over the normal programmed speed of 18 km/h) on a downhill on the route which indicated also that the regenerative

braking system did not work properly. Finally, after 14 departures and 4 hours of driving, the shuttle stopped next to the Kivikko sports park bus stop and did not move anymore. After trying to solve the issue, the shuttle was towed to its charging place and it was found out that the shuttle does not receive power. The shuttle was later transported by trailer to Metropolia's garage where the 80V battery was replaced (Figure 41). The operation was started again on 22nd of October but after a few days of operation the same over-speeding issue occurred and a decision was made to stop the operation until further notice by the supplier. Eventually the shuttle was not operational after 25th of October and the final 14 days of planned operation were not realized. In total 23 days and 414 departures were left undriven because of the issue related with the shuttle's battery.

Figure 41: Towing robot bus on a trailer after facing technical issues in Kivikko [Ismailogullari 2018].

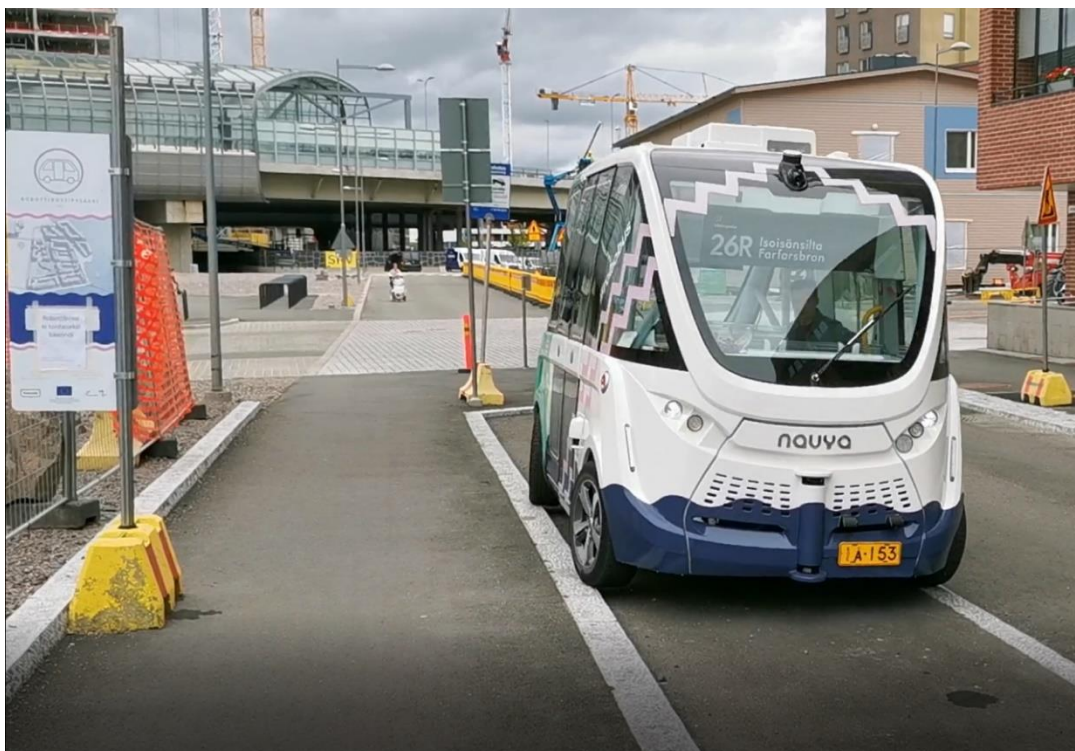
- **Repetitive localization issue by the Redi robot bus stop and its vicinity,** because of which the shuttle was crossing partly the curb between the pedestrian street and the driveway and did not remain exactly on the programmed trajectory as seen in Figure 42. The issue was noticed for the first time in June after which some logs were sent to the shuttle’s supplier. It was found that it was not safe to continue the operation and the shuttle was out of operation (not taking passengers on board) between 14th of June and 16th of July. During this period the shuttle was every now and then tested and logs were collected according to the supplier’s instructions. After some updates the issue was fixed but on 28th of August the issue was again noted and the shuttle was not operational until 18th of September. After a map update the operation could be continued, but vague behaviour

Figure 42: The shuttle crossing the curb between the pedestrian street and the driveway in Kalasatama [Rutanen 2019].

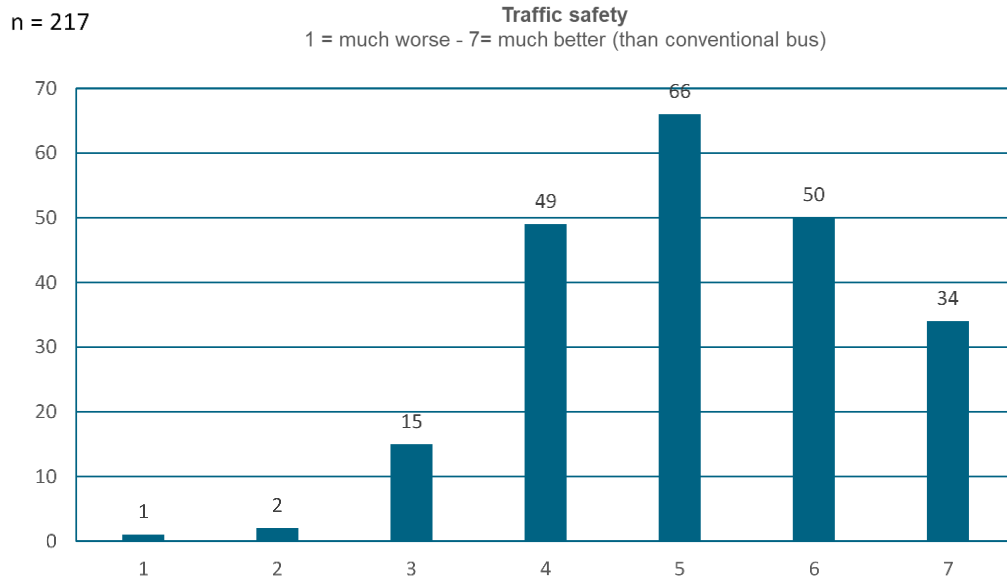
Figure 50: Survey result about considered traffic safety in Kalasatama pilot.

217 passengers in Kalasatama answered the survey of their experiences of travelling in a driverless shuttle and their views about mobility solutions in the future (Annex 2). The first section of the survey advised the respondent to compare his/her travelling experience in a robot bus to travelling in a conventional bus. For example, when asked about traffic safety (Figure 50), 92% (n=217) considered it to be on scale 4 or higher (on the same level or better as in a conventional buses). In case of personal security on board (Figure 51), where 94% (n=217) of the responders thought that it was 4 or higher. According to these results, the passengers generally thought that they felt safer while travelling in the shuttle than in a conventional bus.

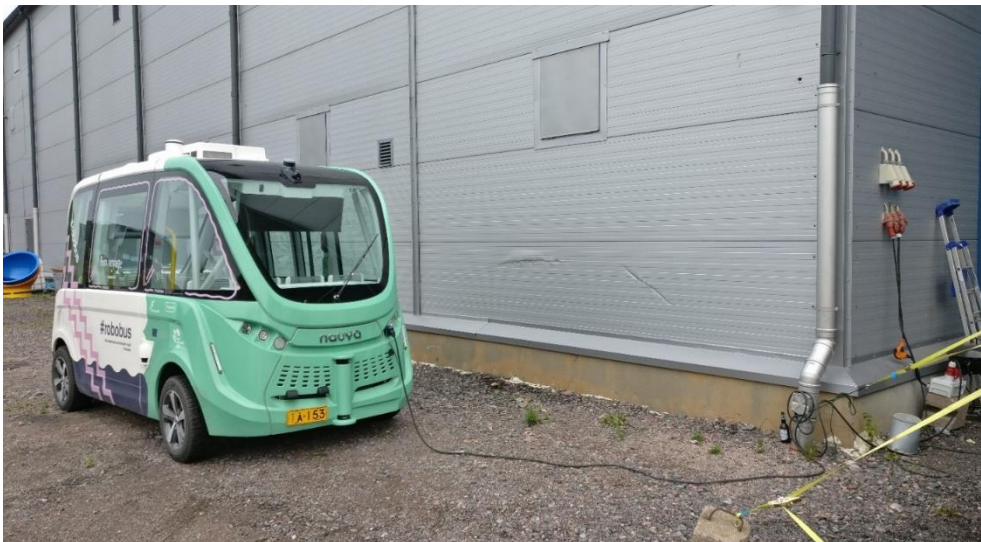
Figure 56: Charging and storing robot bus at Kivikko Skiing hall [Rutanen 2018].

Outside of the operational hours, the shuttle was stored and charged on a yard behind the Skiing hall located at the Kivikko sports park. There was not any suitable indoor storage and charging place at the Skiing hall nor near by the pilot route. Thus, the shuttle was stored and charged outside completely uncovered (Figure 56). In Kivikko a socket of 32 amps power supply was used to charge the shuttle.

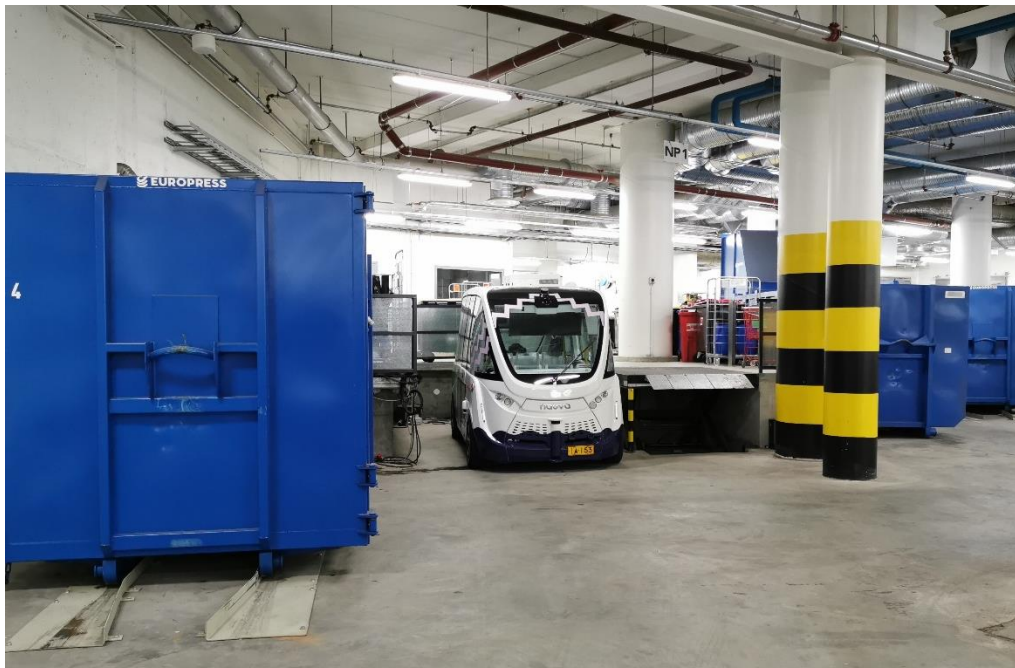
Figure 57: Charging and storing robot bus at Redi shopping mall's service tunnel [Rutanen 2019].
